MARINE INVESTIGATION REPORT
M00W0059

ACCIDENT ABOARD SHIP – ALONGSIDE

FISHING VESSEL – SALMON TROLLER “C - JOY”

13 MARCH 2000

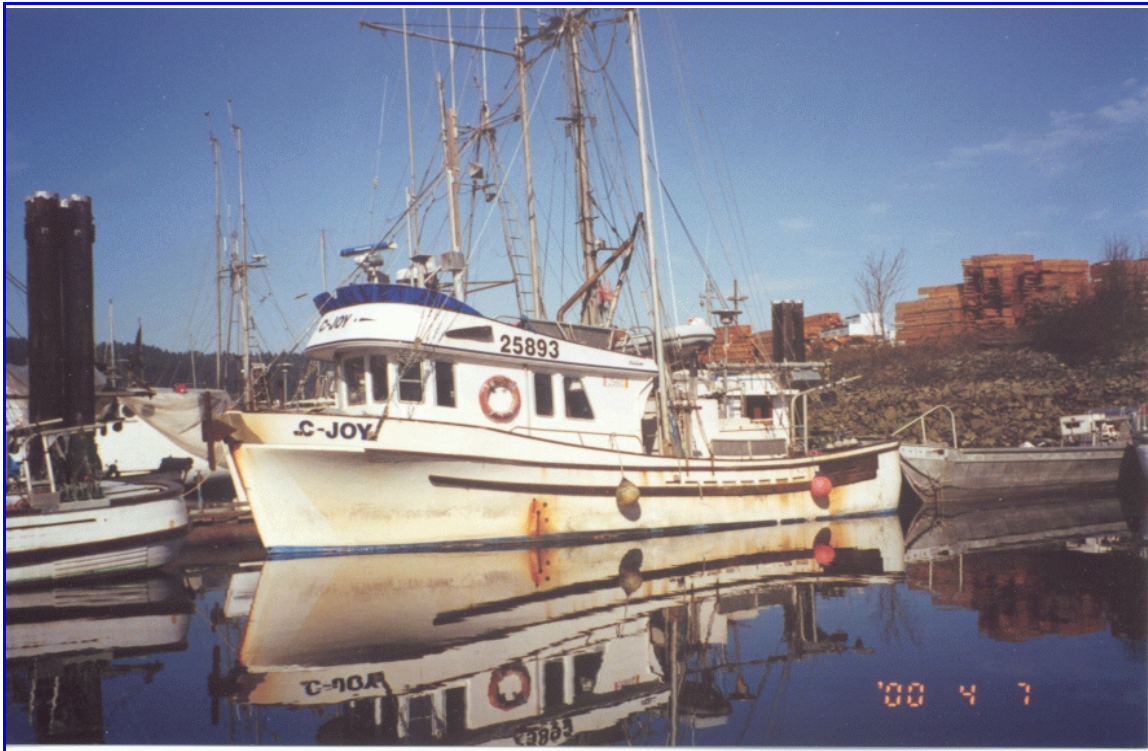
Photo 1. The “C-JOY” secured to a public dock in Port Alberni, B.C., on 7 April 2000.

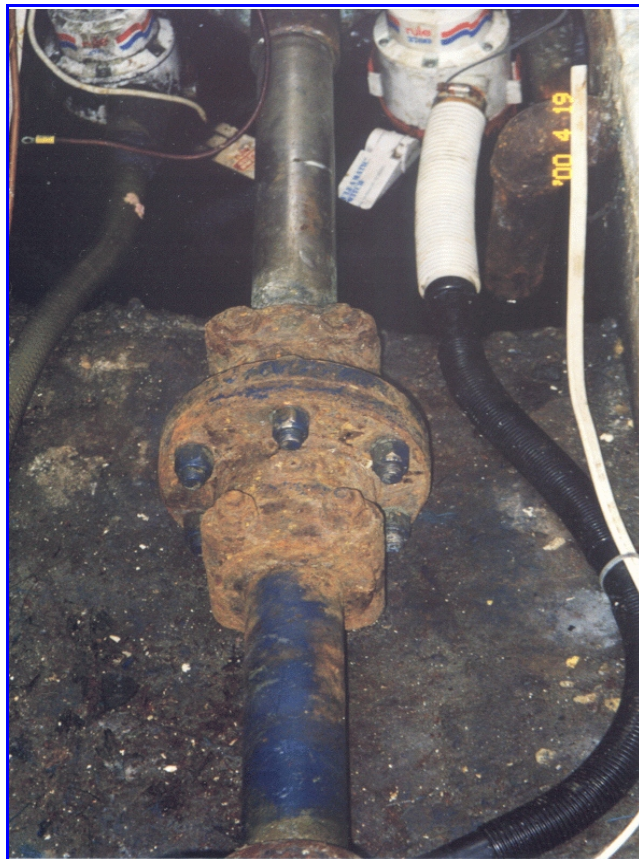
Beneath the centre line compartment is a recessed longitudinal void space (i.e., shaft well) through which pass the intermediate and propeller shafts connected by a shaft coupling (see Photo 2). This arrangement of shafts and coupling transmits power from the main engine to the vessel’s propeller.

Photo 2. Shaft coupling and coupling bolts.

The shaft well is approximately 3.15 m long, 610 mm wide, and 310 mm high. The distance between the shaft coupling and the sides of the shaft well is approximately 150 mm. Access to the shaft well and shaft coupling is by a heavily constructed glass reinforced plastic cover, which extends as a single unit from the forward transverse bulkhead of the fish hold aft to approximately 1.12 m forward of the after transverse bulkhead.

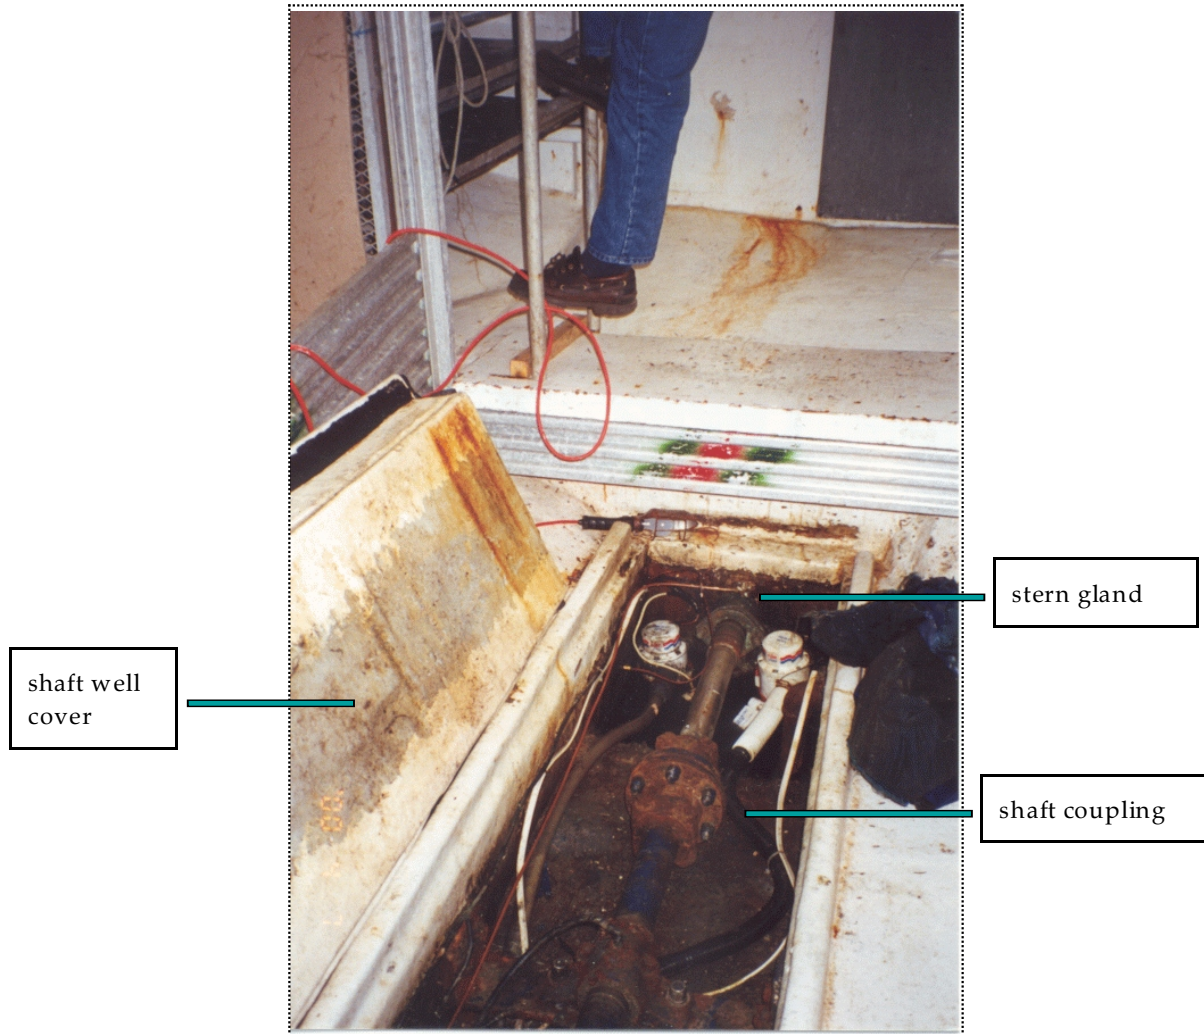
A four-rung aluminum ladder is fixed between the after starboard side of the raised hatch located on the main working deck and a painted, 1.19 m x 510 mm x 19 mm plywood platform in the fish hold at the base of the ladder. The surface of the platform, which is 40 mm above and directly abaft the shaft well, is gouged and worn (see Photo 3).

Photo 3. Part of the fish hold, looking aft, showing the spatial relationship between the foot of the aluminum ladder, stern gland, shaft well cover, and shaft coupling.

The one-piece shaft-well cover extends over most of the length of the fish hold. The removal of the cover to permit the owner/operator access to the stern gland also exposed the rotating shaft coupling located 600 mm forward of it.

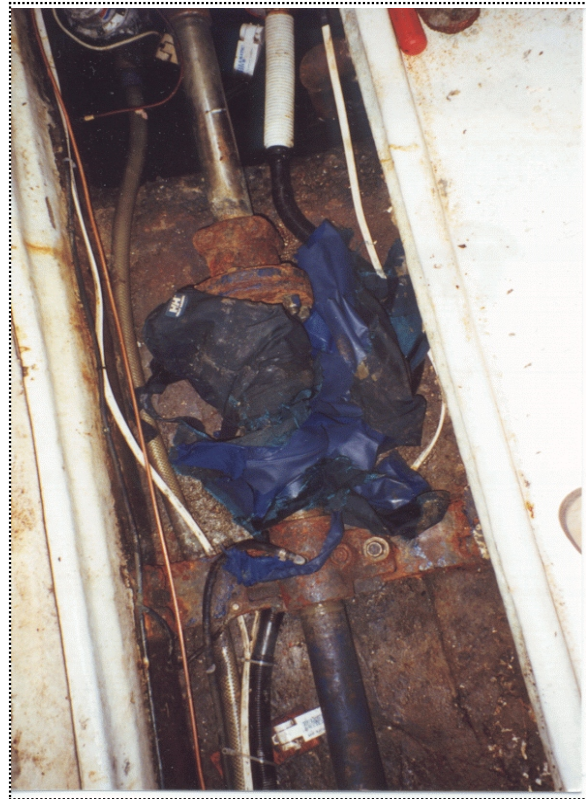
As the owner/operator reached the platform at the base of the ladder, he lost his footing. His legs went forward from underneath him and the left cuff of his weather protective trousers became entangled in the bolts of the rotating shaft coupling (see Photo 4). The operator's left leg was drawn progressively into the 150 mm void between a shaft coupling and the interior port side of the shaft well.

Photo 4. Remnants of the owner/operator's rain pants entangled in the shaft coupling and shaft.

The rain pants worn by the owner/operator were sewn of tear-resistant material. A person wearing garment of this material is likely to find it more difficult to free it from moving machinery than if it had been made of material less resistant to tearing.

1. The owner/operator was working alone in a confined space where the guard on turning machinery had been removed.
2. The removal of the shaft well cover to work on the stern gland also exposed the rotating shaft coupling which caught and trapped the hem of the owner/operator's rain pants.
3. The severity of the owner/operator's injuries was due to his inability to stop the rotating propeller shaft and to the tear-resistant fabric of the rain pants worn by him. The fabric did not tear when first caught and the owner/operator's leg was drawn into the rotating shaft coupling with it.

The manufacturer of these tear-resistant garments will henceforth affix a warning label to the garments instead of to the garments' stowage bag.

The warning label itself has been re-phrased to caution the wearer not to wear the garments when working near exposed moving machinery. The exact wording of the new label is as follows:
